Philips redesigns burner for AM

The production and maintenance of quartz burners was causing some trouble. That's why Philips decided to redesign the burners, with the help of Sirris' expertise in additive manufacturing.

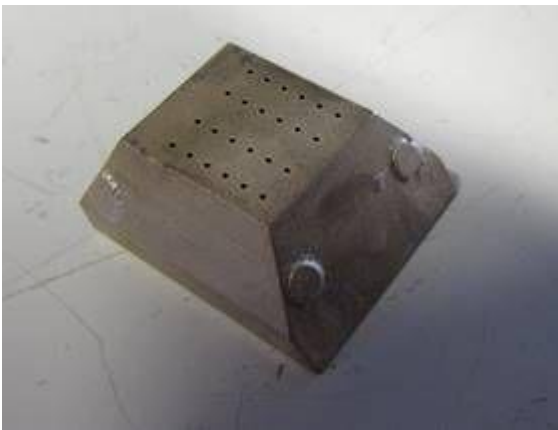
Old burner

The old burners were made from a copper alloy - to ensure proper cooling and because it allowed for brazing. However, the holes caused when the cooling channel was drilled, had to be closed.

The production of these burners met with quite some problems: it is not easy to make the drill holes watertight by means of brazing. When the first drill hole was soldered and the technician would

start on the second one, the first one would start to leak again because of the heat needed to solder the second one properly. When heating quartz, a lot of quartz fumes are released which are then deposited in cold places (for cooled burners). This meant the burners had to be cleaned (sandblasted) very often, which also caused the burners to leak.

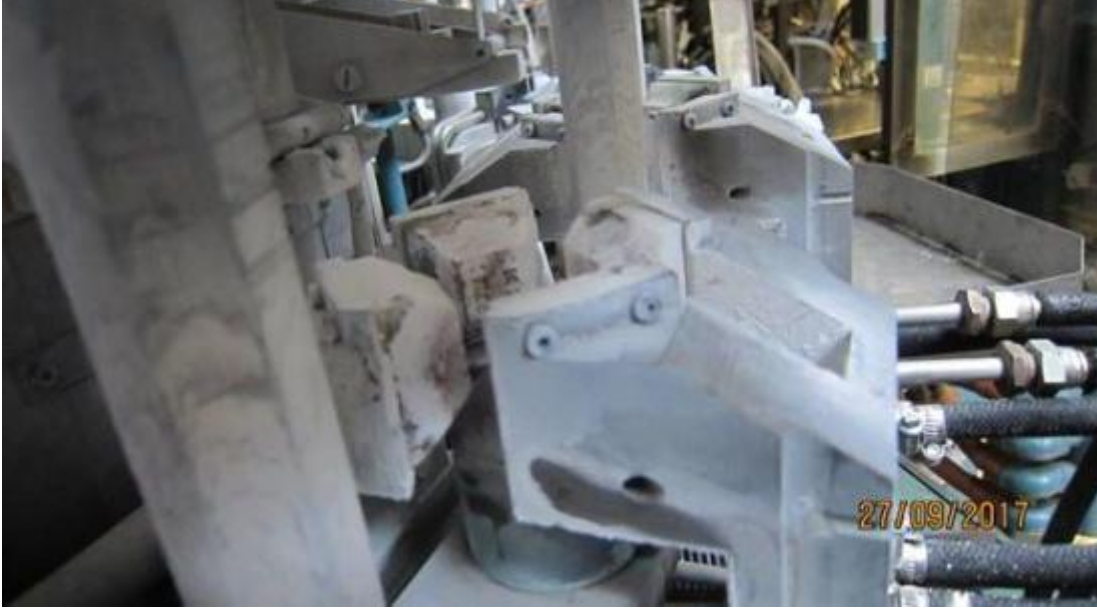
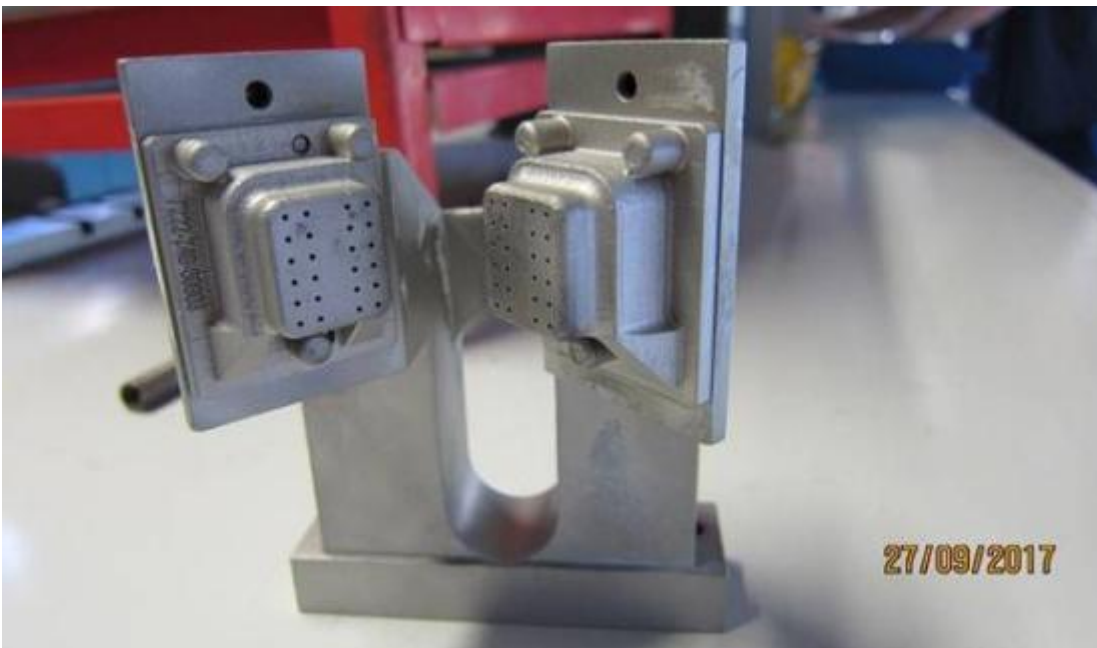
The new burners assembled and cleaned

In the redesign process the cooling channel was placed in the most optimal position and Philips used inconel as an alternative material, which has the property of absorbing fewer quartz vapours.

The places where O-rings were to be installed required post-processing to ensure that the burners would not leak there. Then tests were carried out and temperatures measured.

After two years there is still no need to replace the new burners. Cleaning requires no more than simply blow them clean with compressed air. This is definitely a successful redesign!

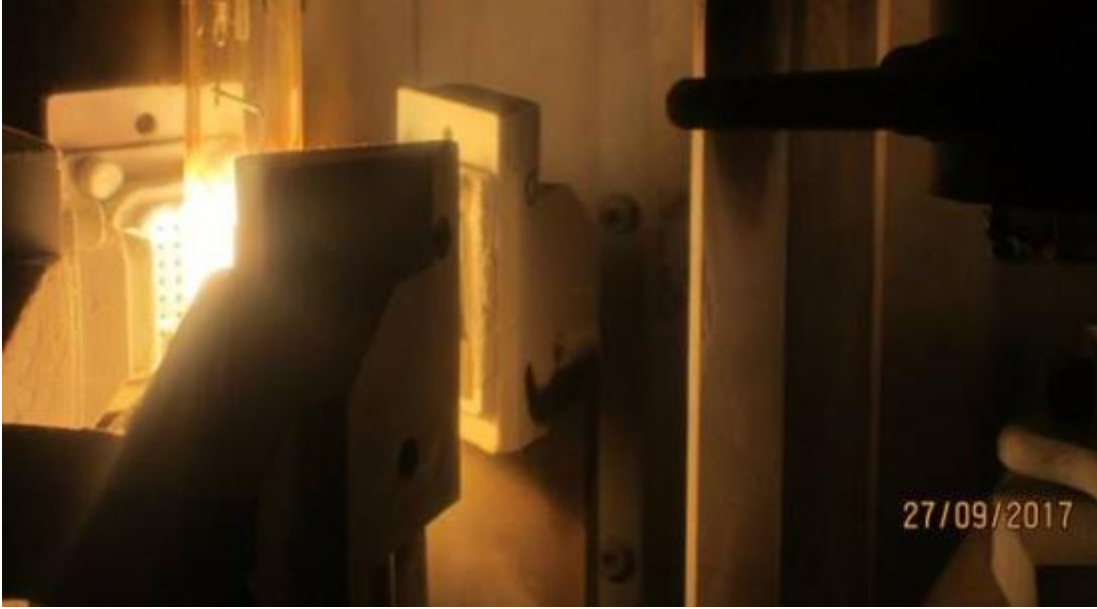
The new burners in action
