Philips redesigns burner for AM

The production and maintenance of quartz burners was causing some trouble. That's why Philips decided to redesign the burners, with the help of Sirris' expertise in additive manufacturing.

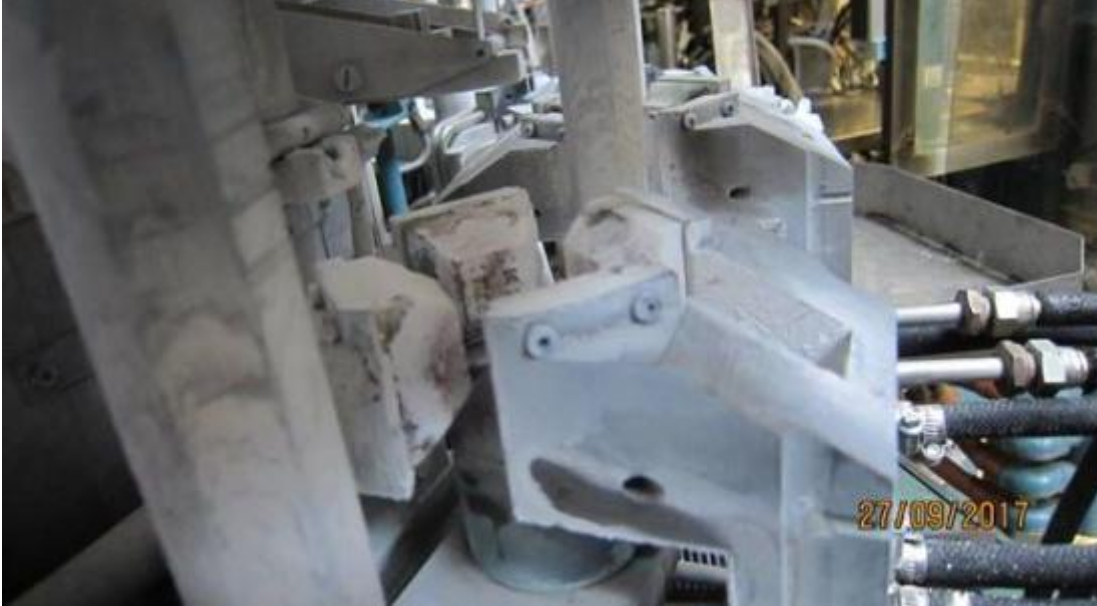
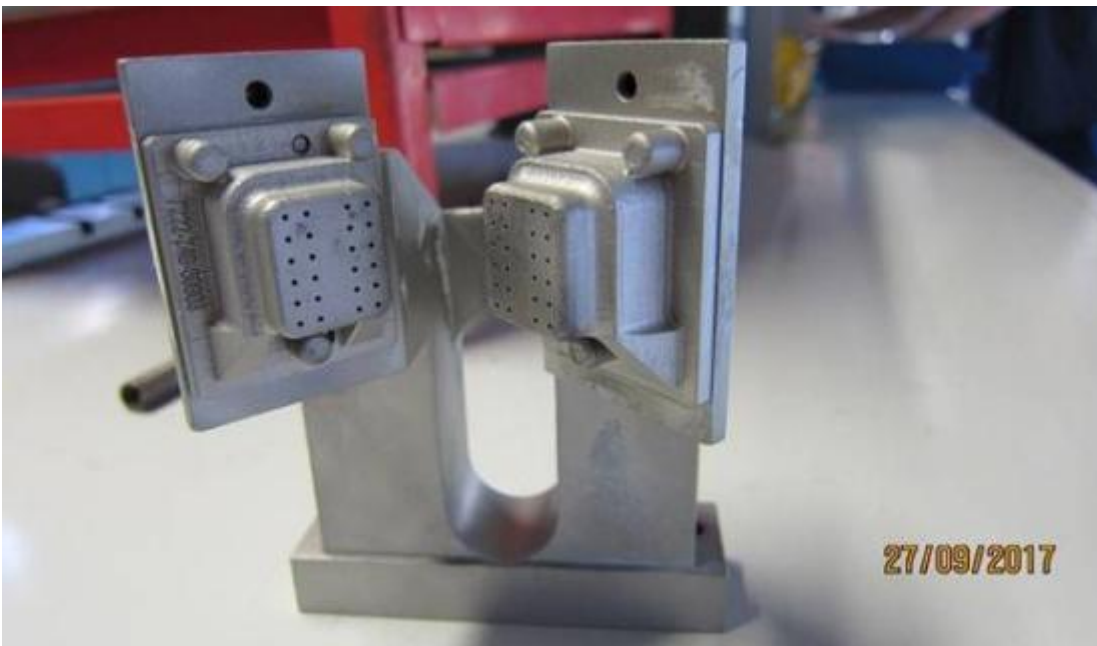
The new burners assembled and cleaned

In the redesign process the cooling channel was placed in the most optimal position and Philips used inconel as an alternative material, which has the property of absorbing fewer quartz vapours.

The places where O-rings were to be installed required post-processing to ensure that the burners would not leak there. Then tests were carried out and temperatures measured.

After two years there is still no need to replace the new burners. Cleaning requires no more than simply blow them clean with compressed air. This is definitely a successful redesign!

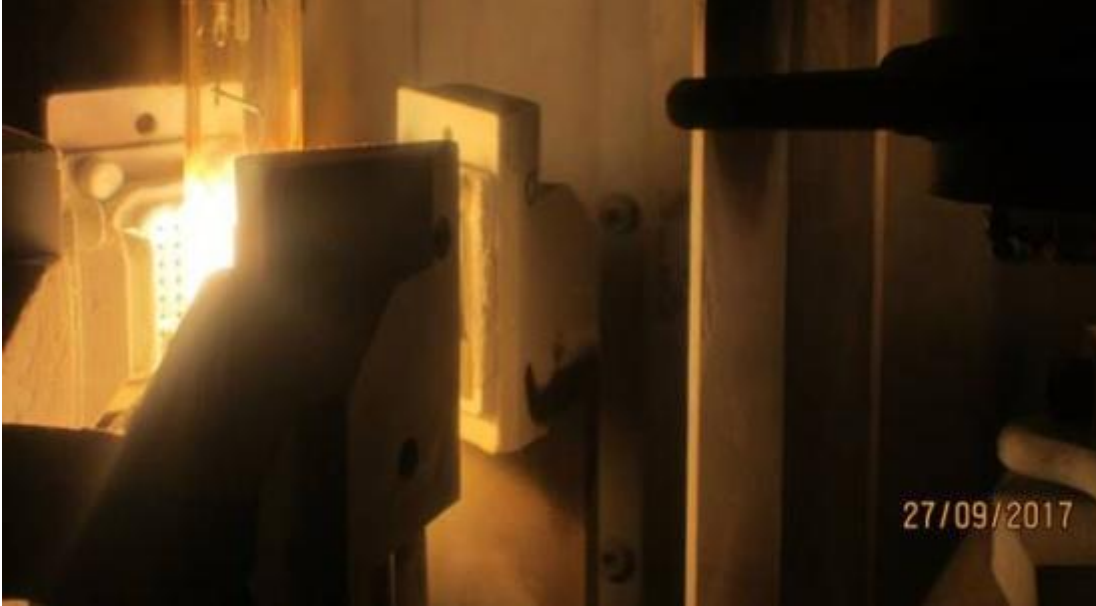
The new burners in action
