Corrosion under insulation

Testing of sensors and coatings in simulated industrial environment

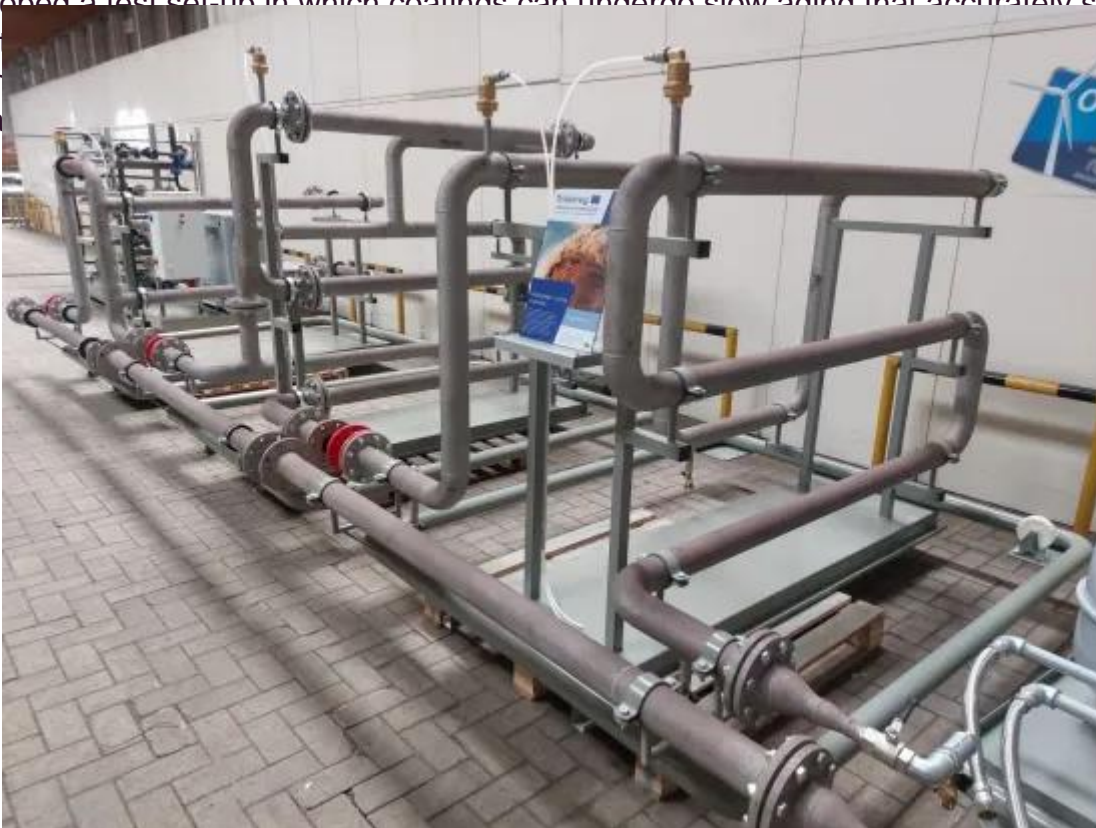
Test setup for evaluating coatings for COI on eight horizontal pipes (Photo taken before applying insulation)

Specifically, in the **development of new coatings** it is important to be able to evaluate the performance of coatings under various conditions. Today various international standards are available for this purpose, but the relevance of these tests for correctly assessing the useful life under field conditions is often a matter for debate. Therefore Sirris, in cooperation with Scalda, has developed a test set-up in which coatings can undergo slow aging that accurately simulates actual conditions. The test set-up is shown in the picture of the accelerated coating degradation.

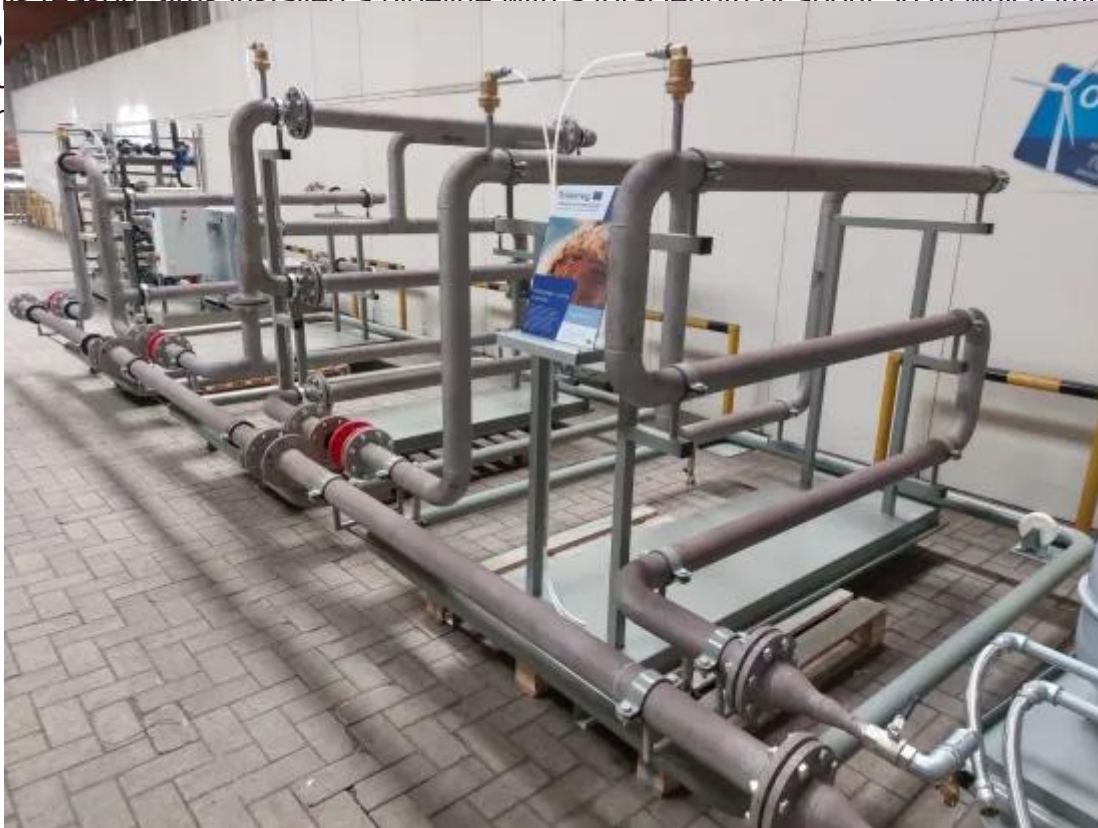
Test setup for evaluating sensors for COI. (Photo taken before applying insulation)

For this reason Sirris installed a pipeline with a total length of about 50 m which imitates the possibilities of various types of sensors. The complexity of the pipeline is similar to that of a real pipeline, which type
