Corrosion under insulation

Testing of sensors and coatings in simulated industrial environment

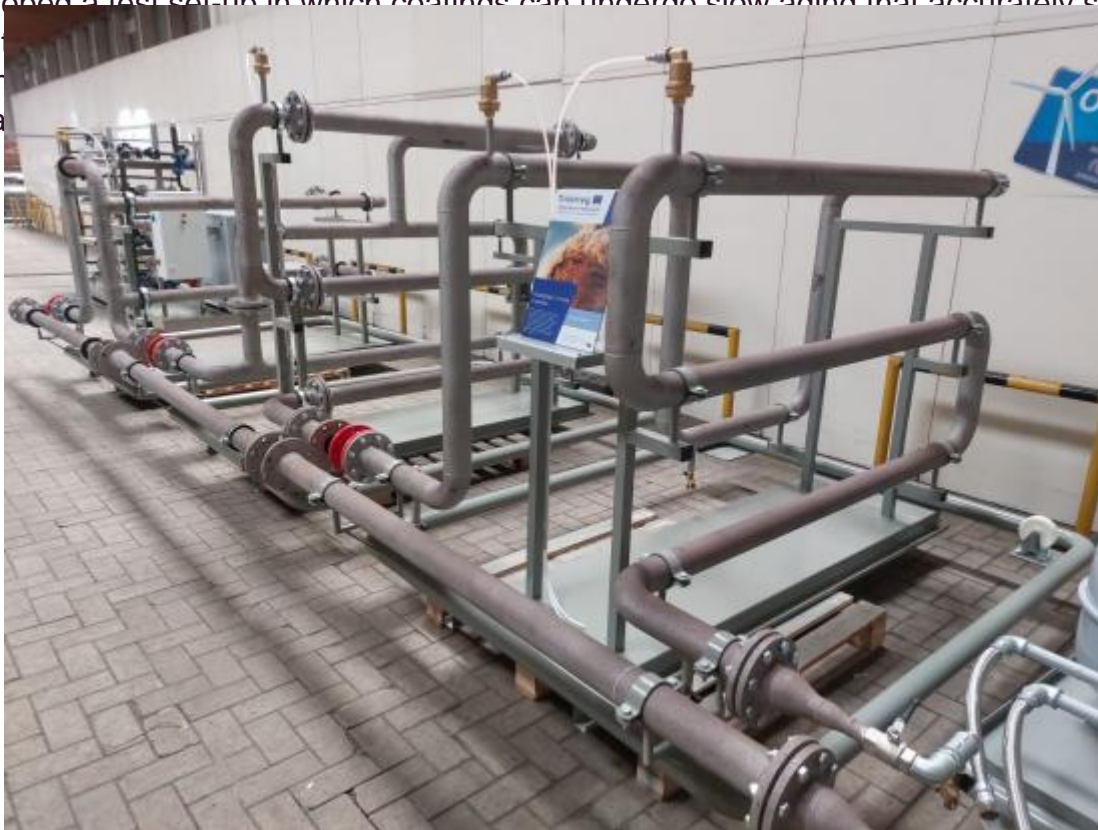
Test setup for evaluating coatings for COI on eight horizontal pipes (Photo taken before applying insulation)

Test set-up for slow aging of coatings

Specifically, in the **development of new coatings** it is important to be able to evaluate the performance of coatings under various conditions. Today various international standards are available for this purpose, but the relevance of these tests for correctly assessing the useful life under field conditions is often a matter for debate. Therefore Sirris, in cooperation with Scalda, has developed a test set-up in which coatings can undergo slow aging that accurately simulates actual conditions. The test set-up is shown in the picture of the accelerated coating degradation.

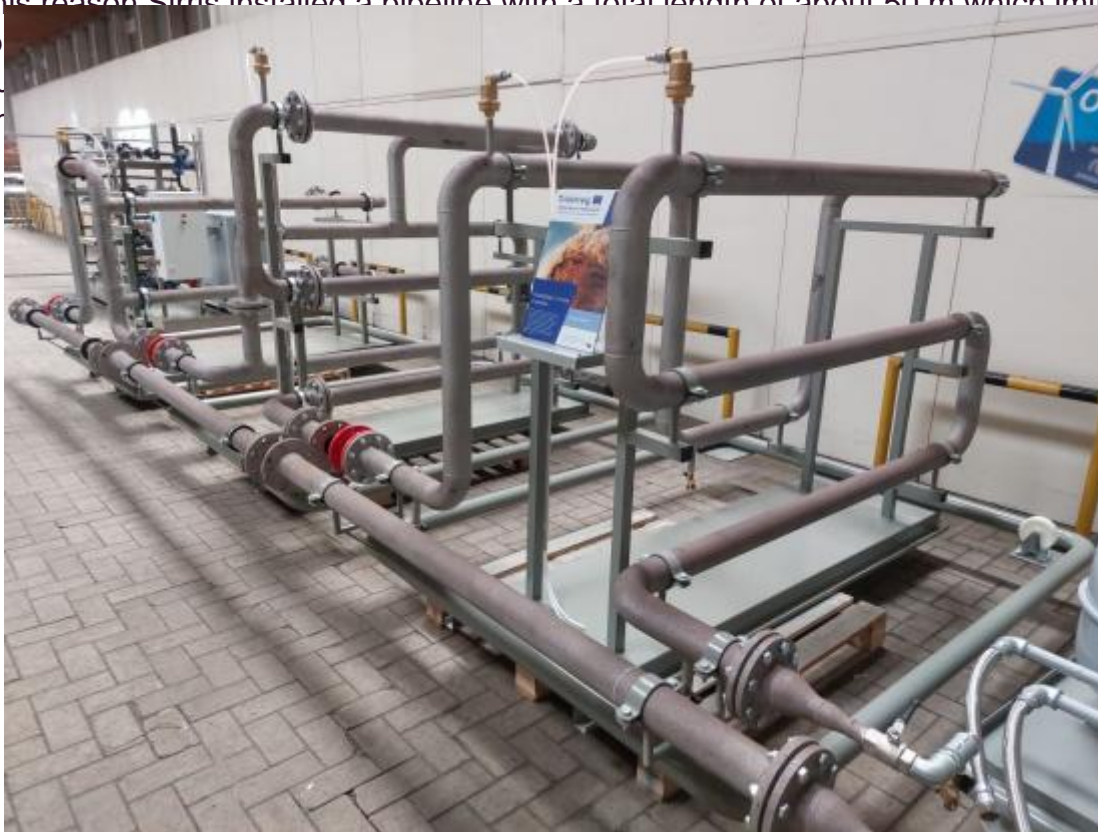
Test setup for evaluating sensors for COI. (Photo taken before applying insulation)

For this reason, Sirris installed a pipeline with a total length of about 50 m which imitates the possibilities of various types of pipeline which type of sensor can be used.
