Corrosion under insulation

05 September 2023, 22:49

Testing of sensors and coatings in simulated industrial environment

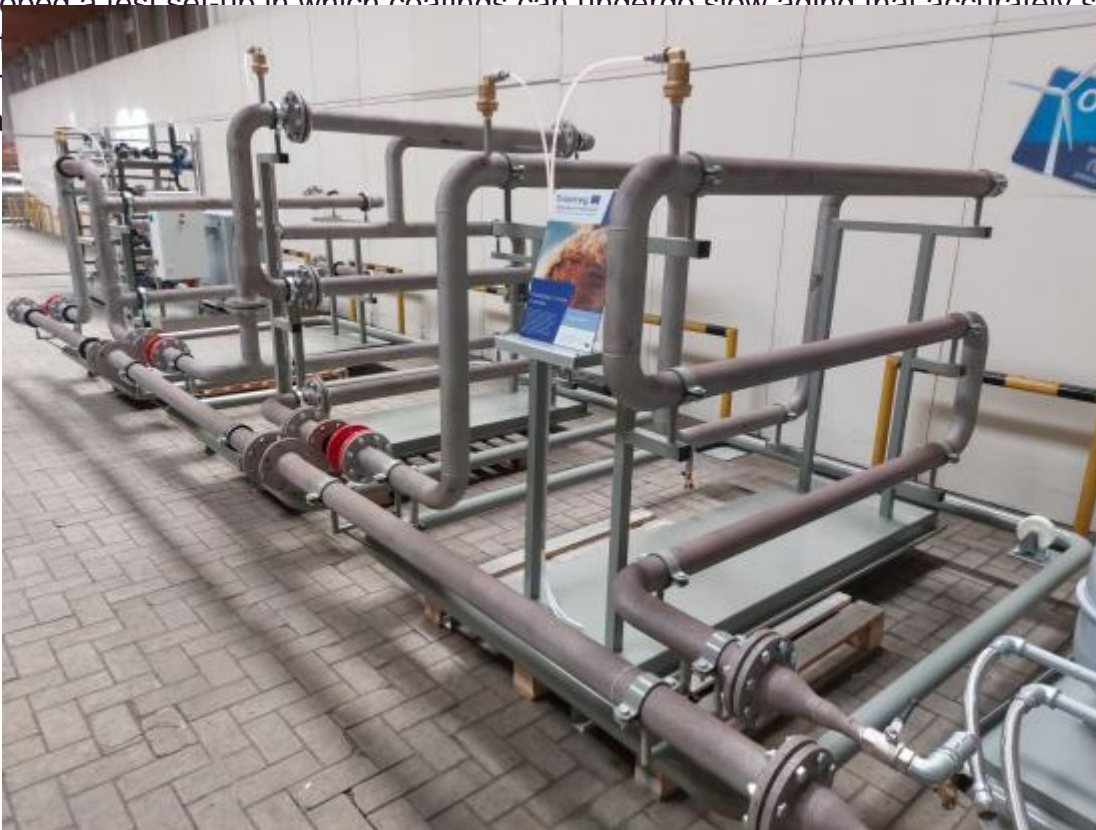
Test setup for evaluating coatings for COI on eight horizontal pipes (Photo taken before applying insulation)

Specifically, in the **development of new coatings** it is important to be able to evaluate the performance of coatings under various conditions. Today various international standards are available for this purpose, but the relevance of these tests for correctly assessing the useful life under field conditions is often a matter for debate. Therefore Sirris, in cooperation with Scalda, has developed a test set-up in which coatings can undergo slow aging that accurately simulates actual conditions. The test set-up is shown in the picture of the accelerated coating degradation.

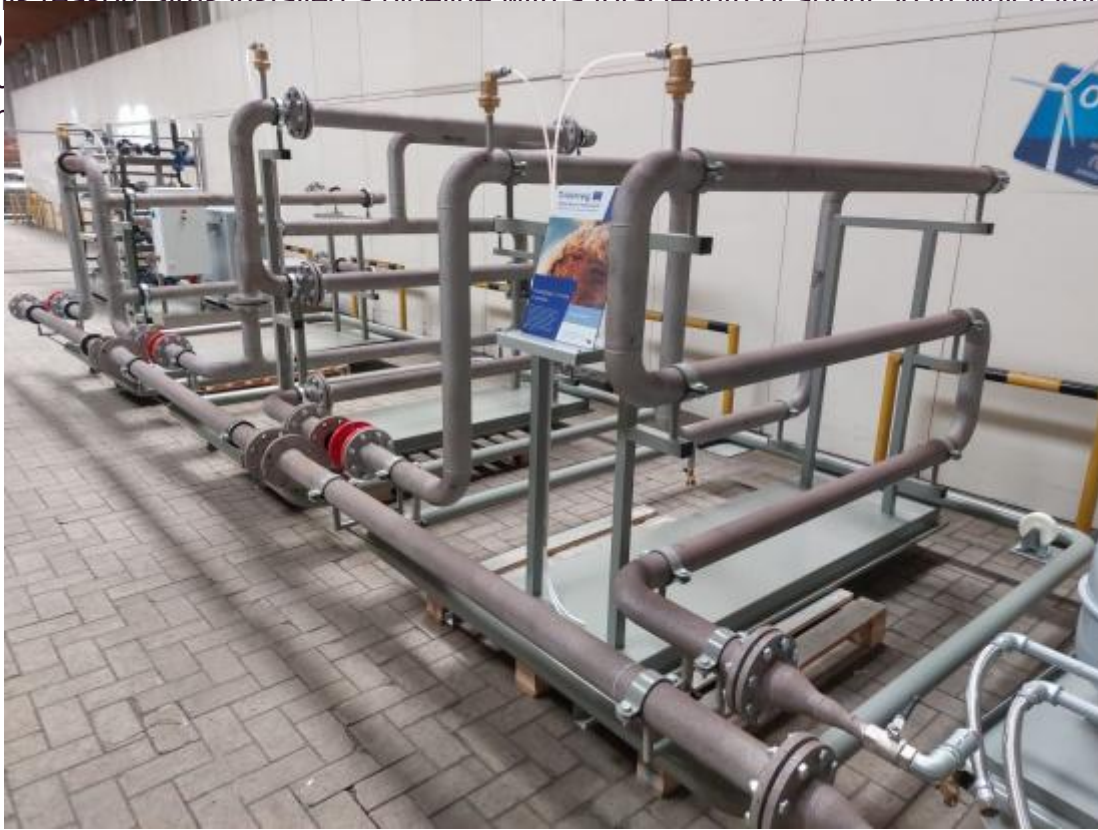
Test setup for evaluating sensors for COI. (Photo taken before applying insulation)

For this reason Sirris installed a pipeline with a total length of about 50 m which imitates the possibilities of various types of sensors and the possibilities of the different types of sensors.
