Ten most common wind turbine failure issues identified

22 November 2021, 01:00

Pieter Jan Jordaens

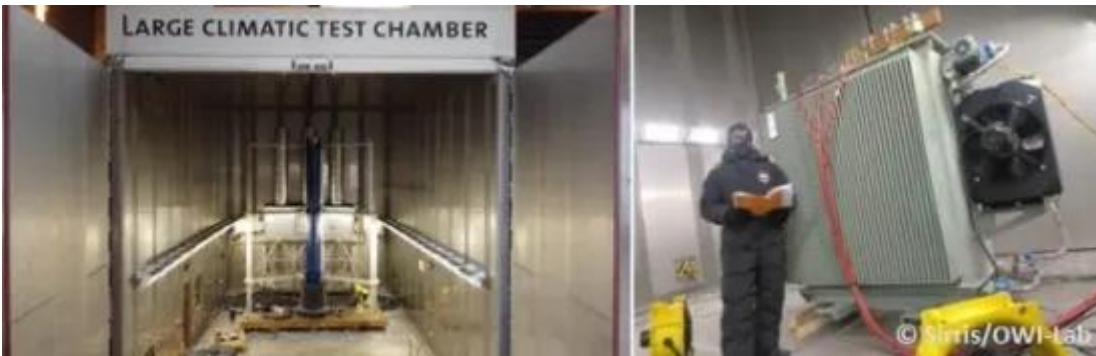
In order to remedy or prevent **temperature problems**, tests are performed under (extreme) global climatic conditions in the large climate chamber in Antwerp. This is to ensure, for example, that certain turbine components do not overheat or experience problems during a cold start. Major players such as [ZF Wind Power](#) and [Siemens Gamesa](#) tested their product prototypes in our climate chamber.

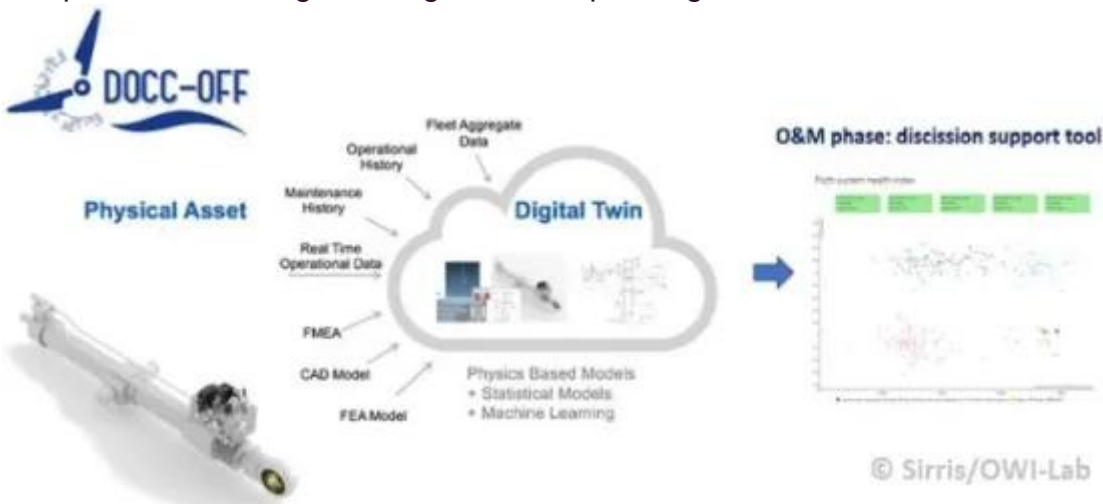
Problems with the hydraulic system are addressed within the European DOCC-OFF project ('Digitalisation of critical components in offshore wind turbines'), which aims, by using the knowledge derived from operational data, to demonstrate the impact of remote sensing and monitoring in optimising the design, increasing performance and reducing maintenance costs of critical subsystems in offshore wind turbines. Thus, offshore wind energy is becoming one of the competitive technologies alongside other power generation alternatives.

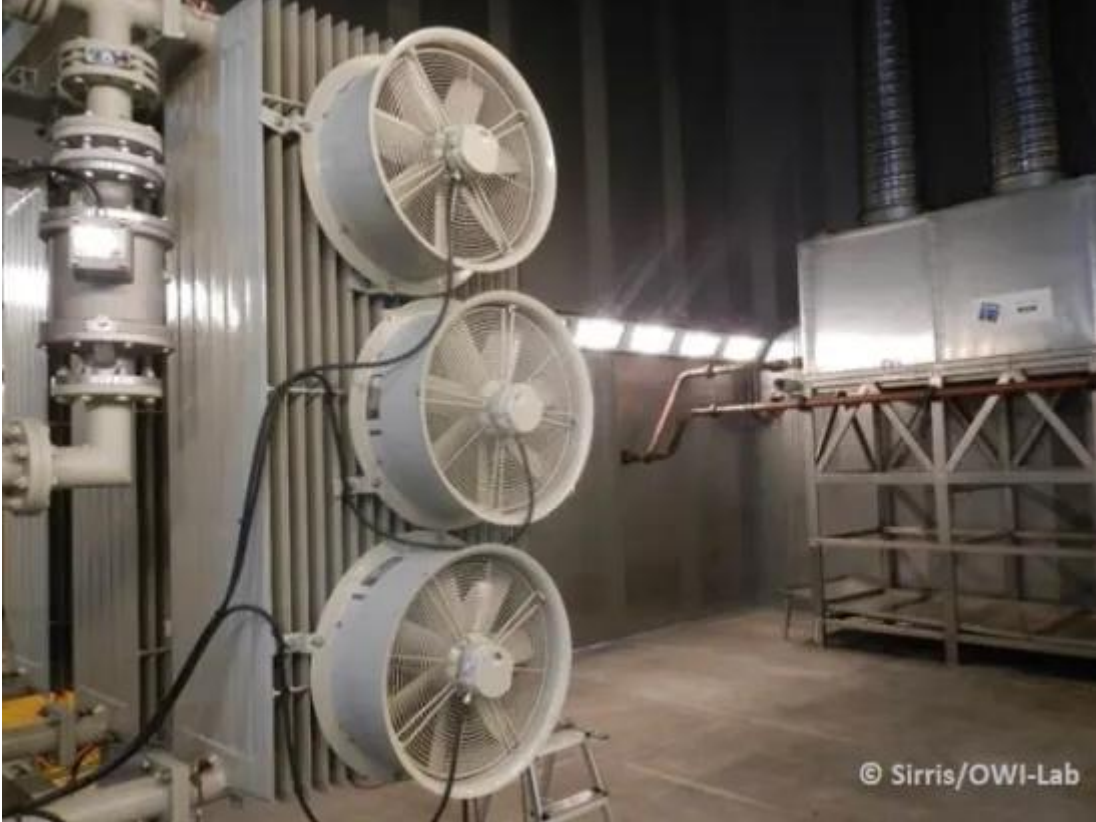
Problems with the cooling system are also investigated in the large climate chamber by testing under (extreme) climatic conditions: this often involves tackling overheating problems and/or testing and validating new cooling types of transformers. This is what happened in the cases we worked on together with [SGB Smit](#) and [CG Power Systems](#).

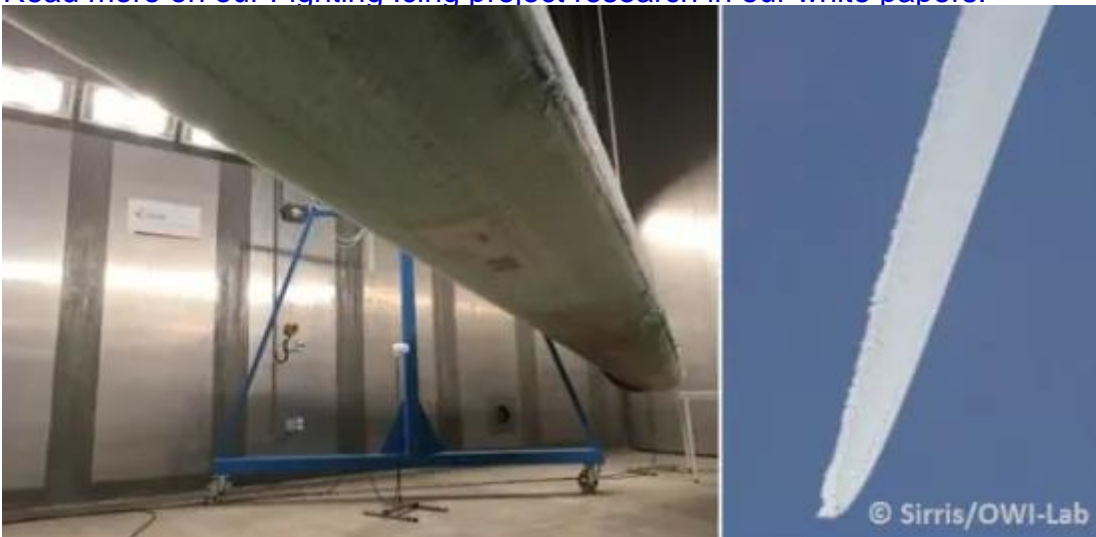
Recently, we have also been able to simulate **ice formation** in the climate chamber thanks to a new [icing test](#) set-up. Within this theme, we also have two ongoing R&D projects: [Fighting Icing](#) which translates the state-of-the-art knowledge and solutions to detect problems of icing in various domains into structured and concrete methodologies for their implementation, and [NewSkin](#) which explores the potential of nano-based surfaces for industrial and consumer products.

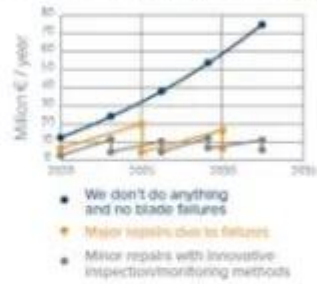
Total financial loss of electricity due to blade leading edge erosion for all offshore wind farms in Belgium

Repair costs of all offshore wind turbine blades in Belgium

Today's practice: major repairs
Solution: minor repairs supported with innovative inspection and monitoring

Years of operation	3	5	7	12
Exemple picture blade leading edge				
Sectional power loss (%)	2.1%	16.7%	22.2%	27.3%

The ICON Project [Rainbow](#), finally, aims to gain a better understanding of **rotor blade erosion** caused by precipitation and lightning, as erosion causes significant production losses. This should
