Corrosion under insulation

Testing of sensors and coatings in simulated industrial environment

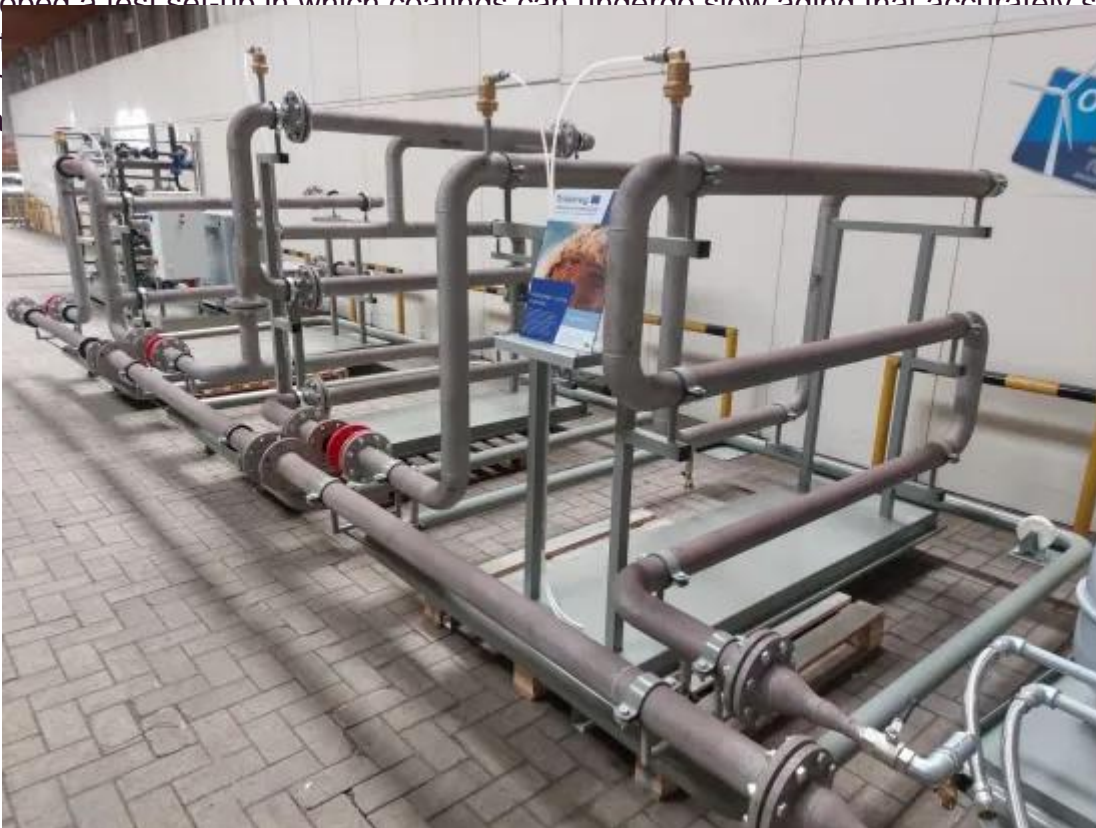
Test setup for evaluating coatings for COI on eight horizontal pipes (Photo taken before applying insulation)

Specifically, in the **development of new coatings** it is important to be able to evaluate the performance of coatings under various conditions. Today various international standards are available for this purpose, but the relevance of these tests for correctly assessing the useful life under field conditions is often a matter for debate. Therefore Sirris, in cooperation with Scalda, has developed a test set-up in which coatings can undergo slow aging that accurately simulates actual conditions. The test set-up is shown in the following picture of the accelerated coating degradation test set-up.

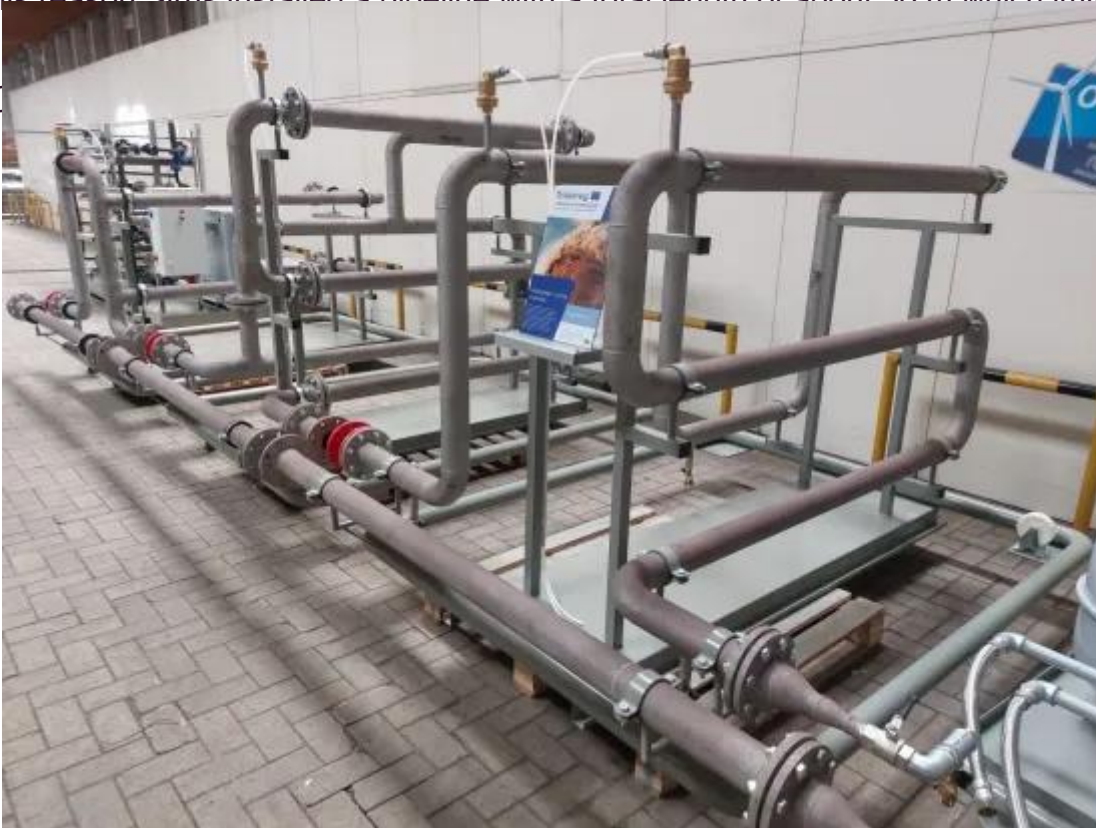
Test setup for evaluating sensors for COI. (Photo taken before applying insulation)

For this reason Sirris installed a pipeline with a total length of about 50 m which imitates the possibilities of various types of sensors and the possibilities of the different types of sensors.
